CONTROL SURVEY MONUMENT RECOVERY

Cathedral City

Name: **PD 23-1**

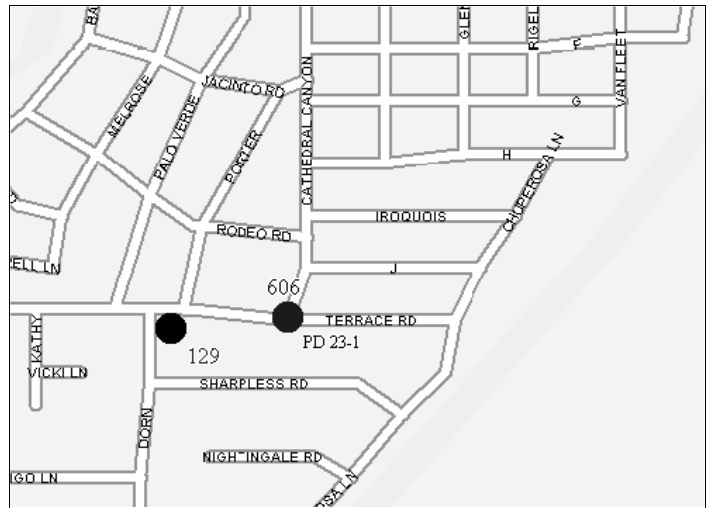
Monument Description: GPS Useable:
Iron pipe in street survey well monument

At the intersection of Cathedral Canyo Dr and Terrace Rd
